Final Report

Completion of Repairs to the Shenandoah (Georgia)
Community Center Solar Heating, Cooling, and Hot Water System

U. S. Department of Energy

Contract
EY-76-S-05-4942, Mod 5

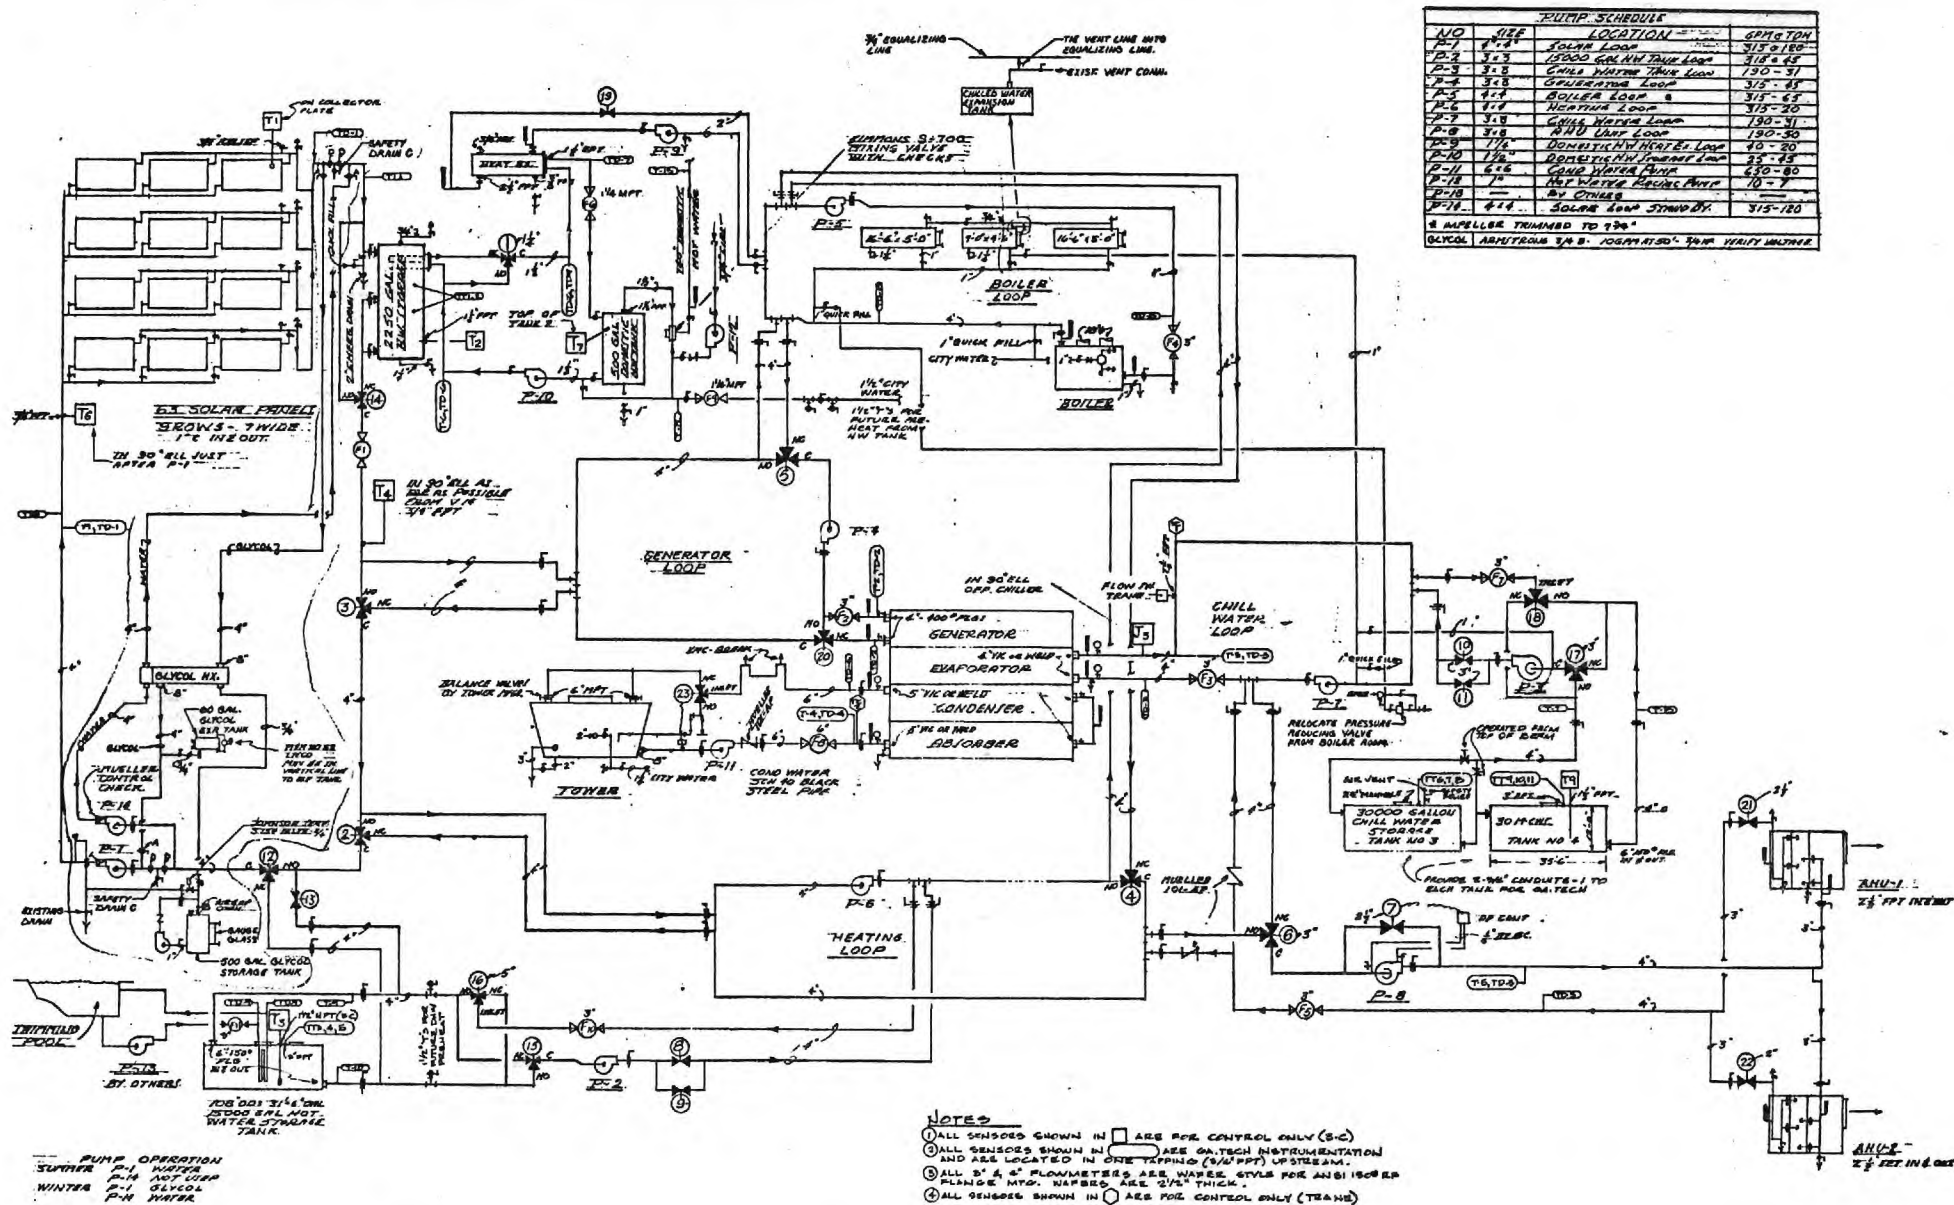
FIGURE 1. THE SHENANDOAH SOLAR SYSTEM IN SUMMER MODE OF OPERATION. Water is circulated in the array for highest collection efficiency during the cooling season. Glycol solution is held in storage tank.

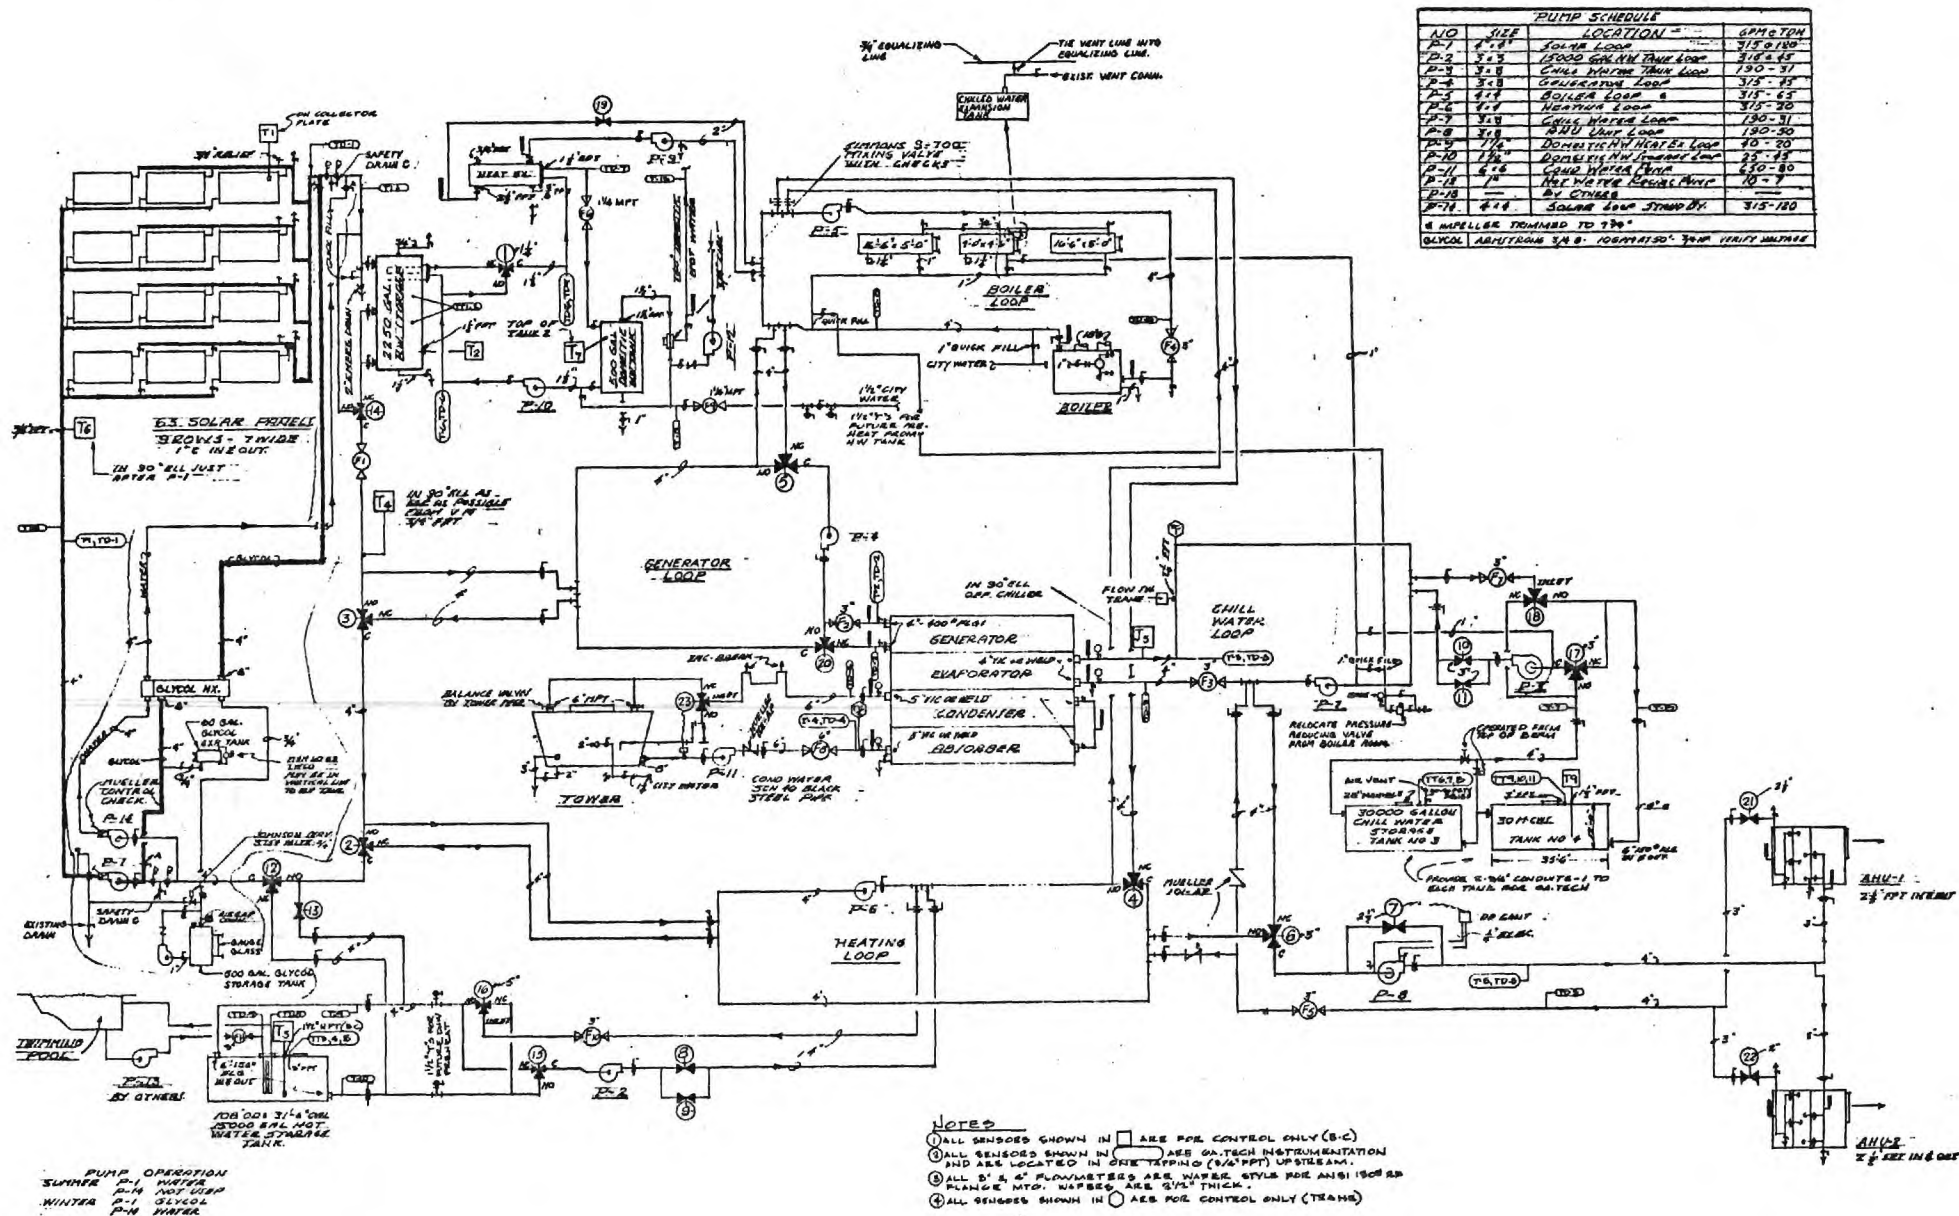
FIGURE 2. SHENANDOAH SYSTEM IN WINTER MODE OF OPERATION. Glycol/Water solution fills all exposed piping in the collector loop (bold lines). Water in balance of system is heated in isolation heat exchanger.
